TECHNICAL REPORT HL-91-15

# HARRY S. TRUMAN DAM SPILLWAY AND POWERHOUSE, OSAGE RIVER, MISSOURI

## Hydraulic Model Investigation

### Volume I MAIN TEXT

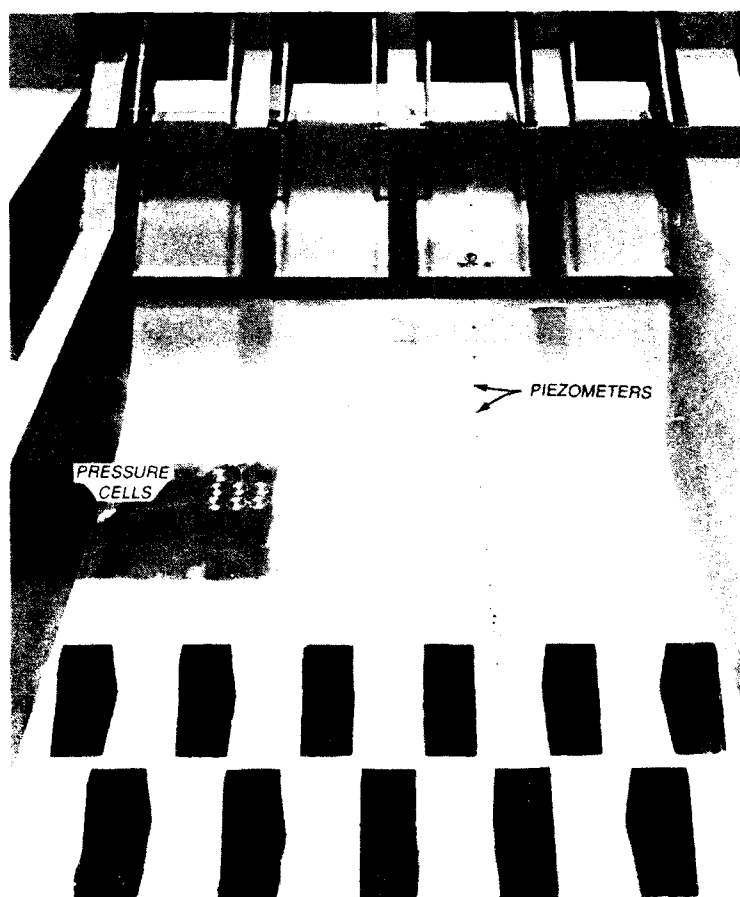
Figure 6. Stilling basin instrumentation

30. Instantaneous pressure measurements were made in the stilling basin at nine locations, shown in Plate 4 and Figure 6, where some of the worst scour damage had occurred in the prototype. These pressure data and plots for discharges of 61,000, 69,900, 70,000, 132,500, 229,000, and 284,000 cfs are provided in Tables 1-6. Expanded plots are located in Appendix A.
